US Army Corps
of Engineers
Construction Engineering
Research Laboratories

USACERL Technical Report 99/25
SFIM-AEC-ET-CR-98009
February 1999

Evaluation of Two Washrack Recycle Treatment Systems

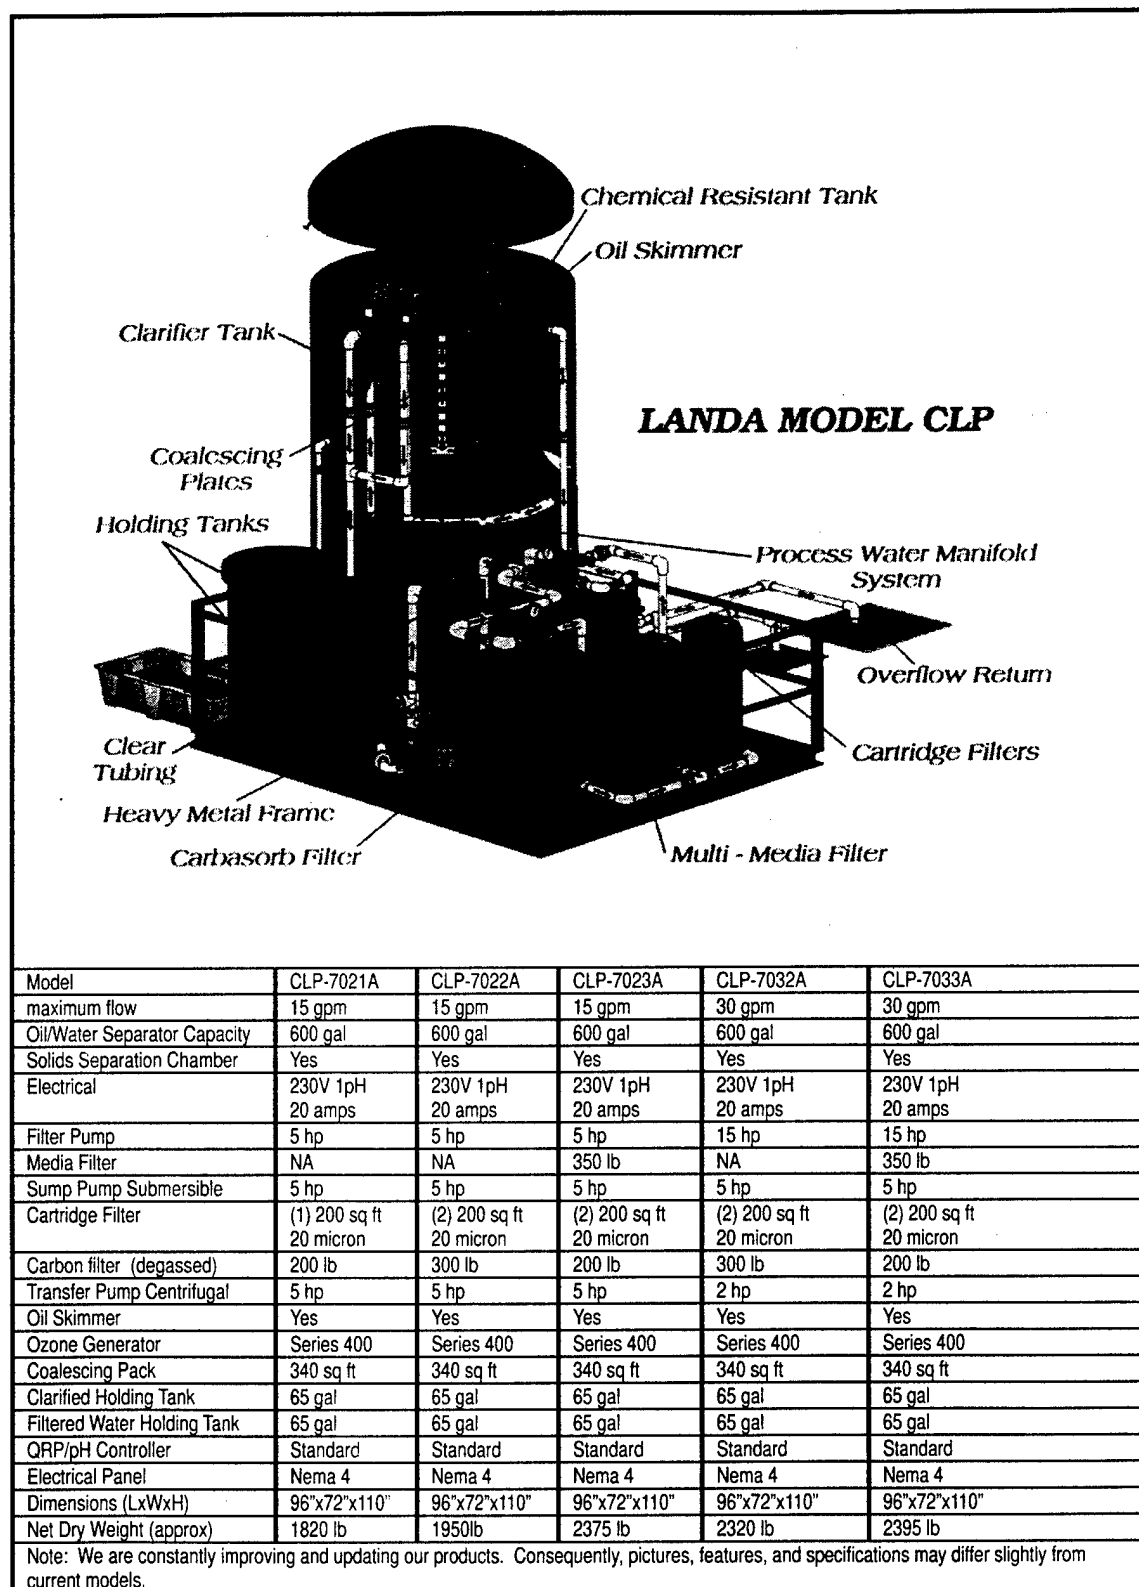
Figure 2. Schematic of evaluated Landa system.

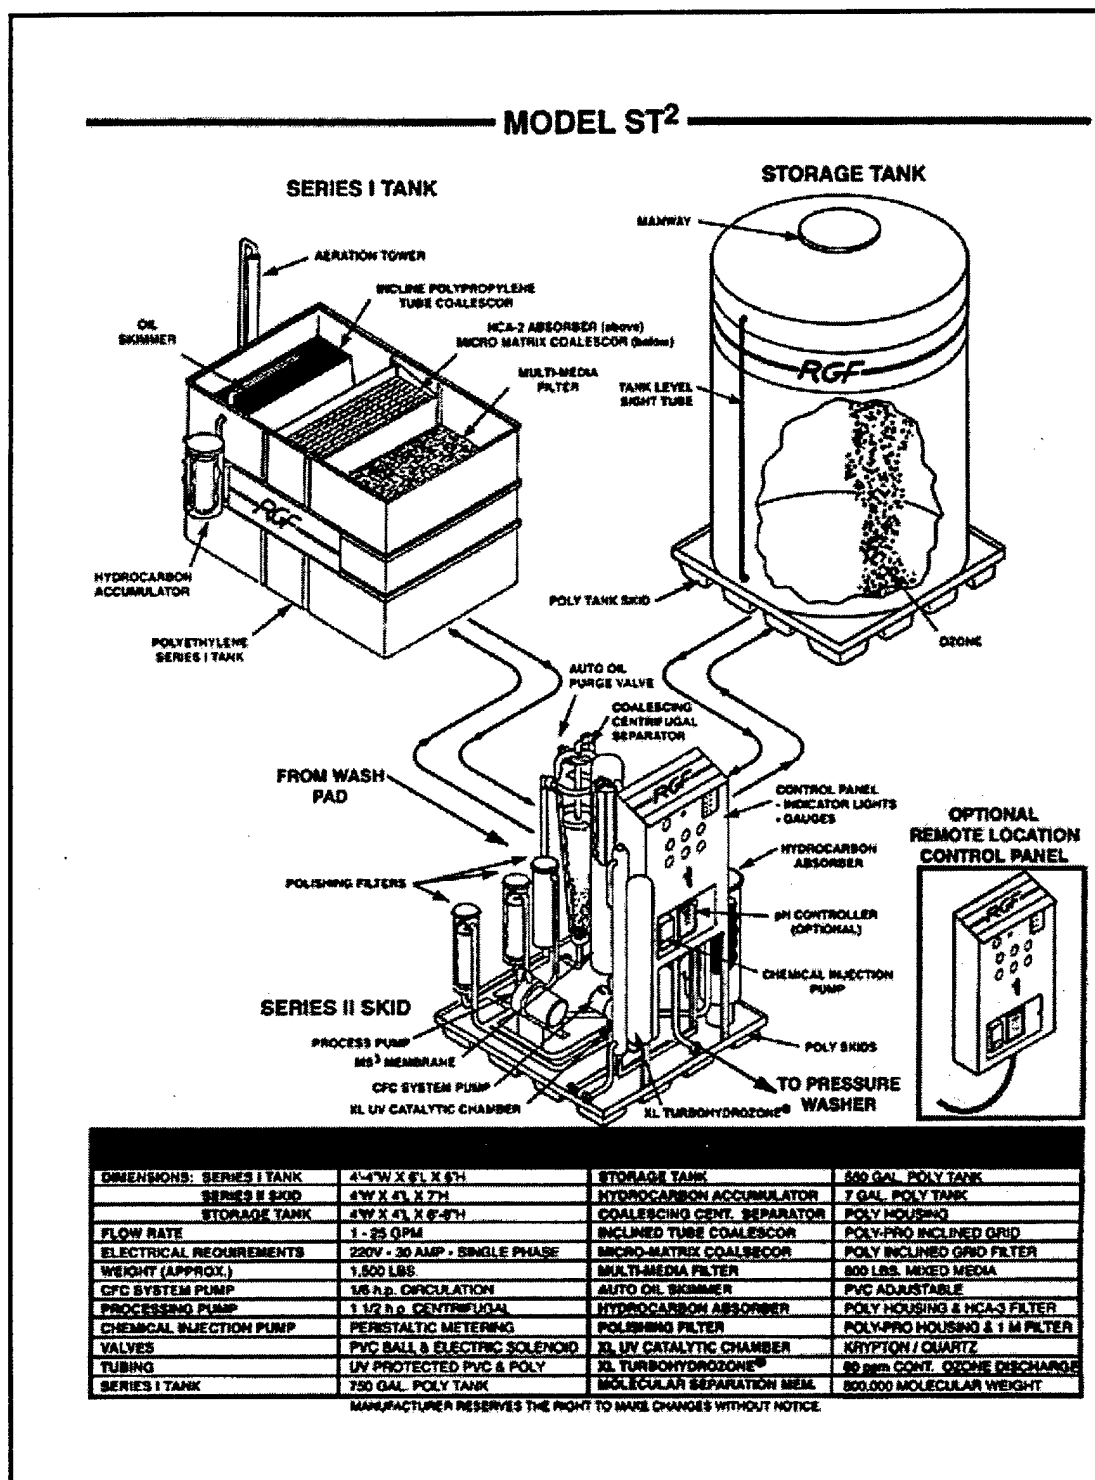
Figure 4. Schematic of evaluated RGF system.

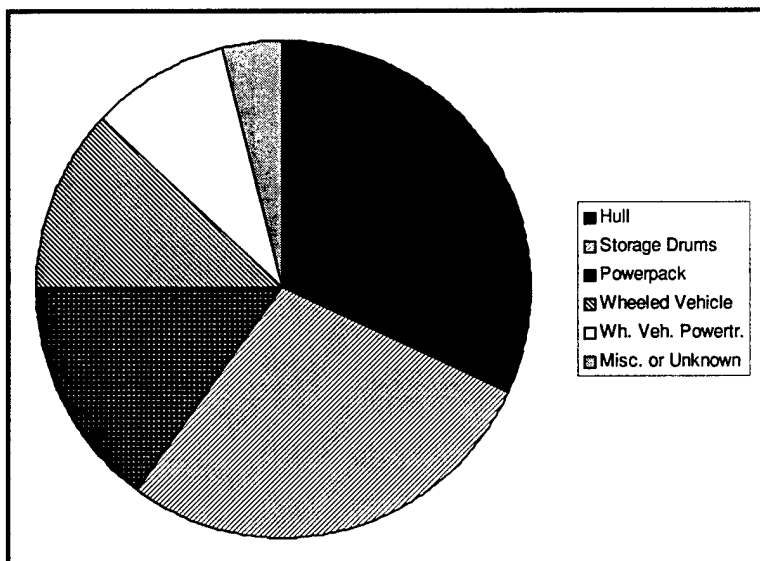
Figure 6. Washrack usage during Landa test.

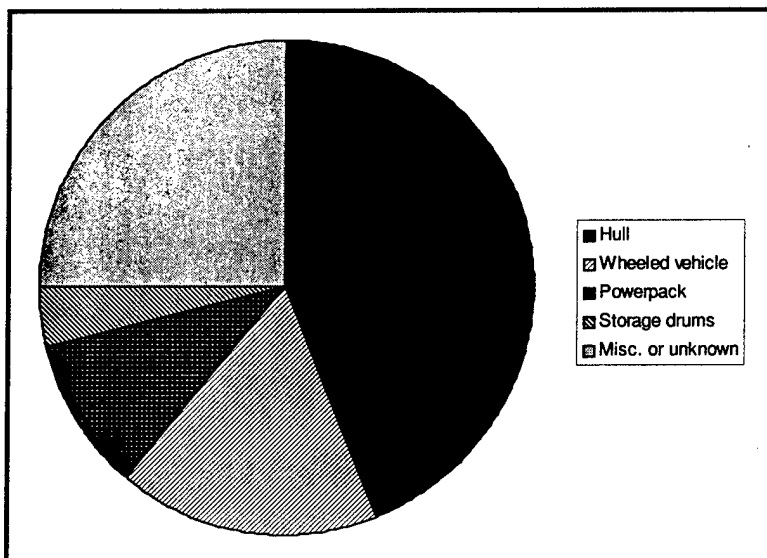
Figure 7. Washrack usage during RGF test.
